**Archeological and Architectural Investigations  
at Brown's Sheep Camp (5LA5824),  
A Multicomponent District in the  
U.S. Army Pinon Canyon Maneuver Site,  
Las Animas County, Colorado**

**National Park Service,  
Midwest Archeological Center,  
Lincoln, Nebraska**

**April 1999**

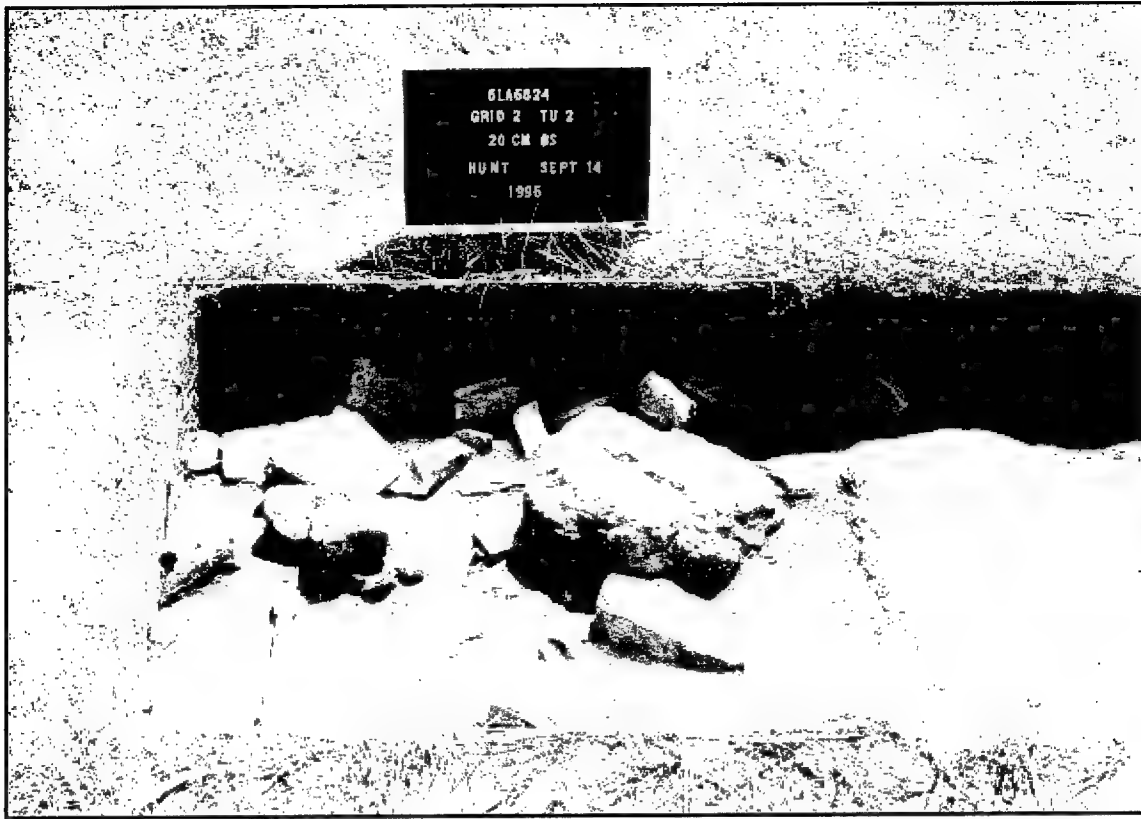
Figure 6. Artifacts and cultural features exposed in Remote-Sensing Grid 2 test units.

In contrast to the investigative results at RS Grid 1, testing confirmed the cultural origins of the anomaly in RS Grid 2. A linear water-resistant feature and stones similar to those noted in extant foundations at the site were encountered. These suggested an adobe wall segment and a possible disrupted stone foundation, both of which were interpreted as structural elements. Based on the size of the anomaly and the features exposed, an estimate of this building's size would be approximately 6 m

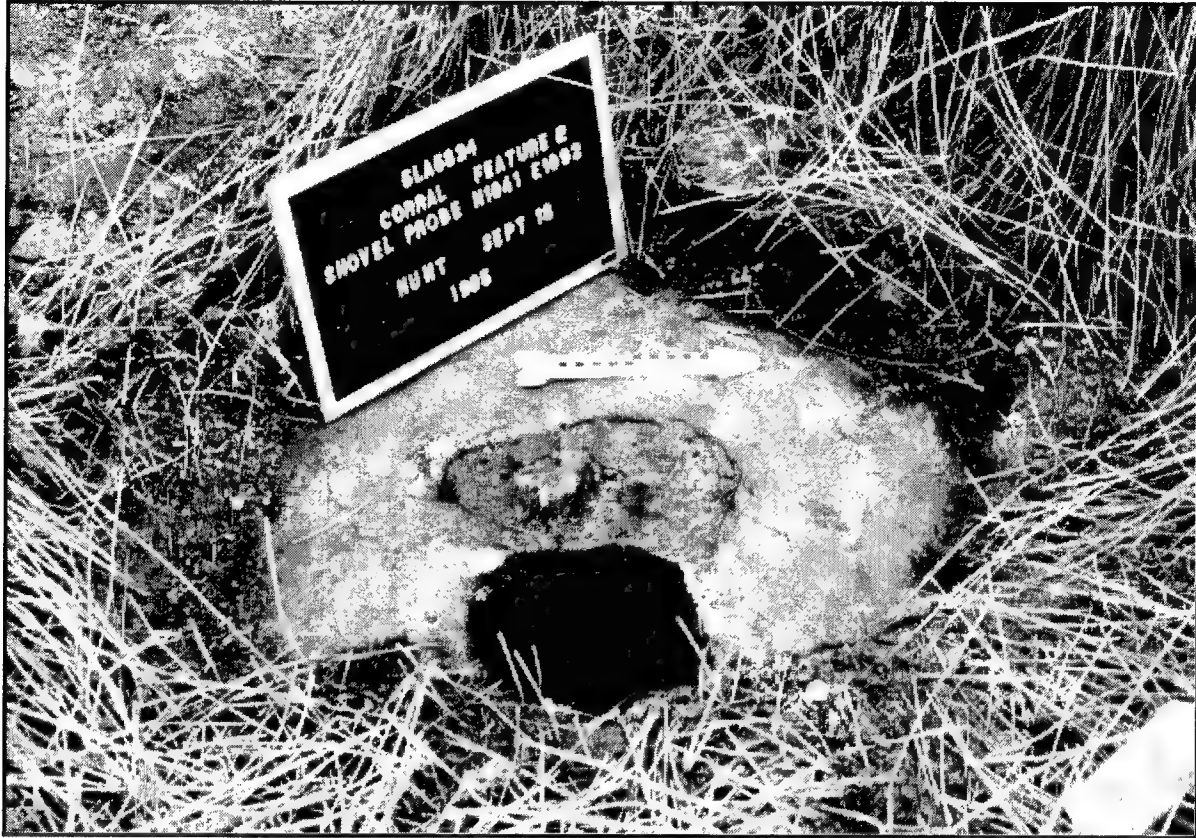
Figure 9. Post mold (Feature 2) located with shovel probe at N1041/E1092, Remote-Sensing Grid 3 (Corral) test area.

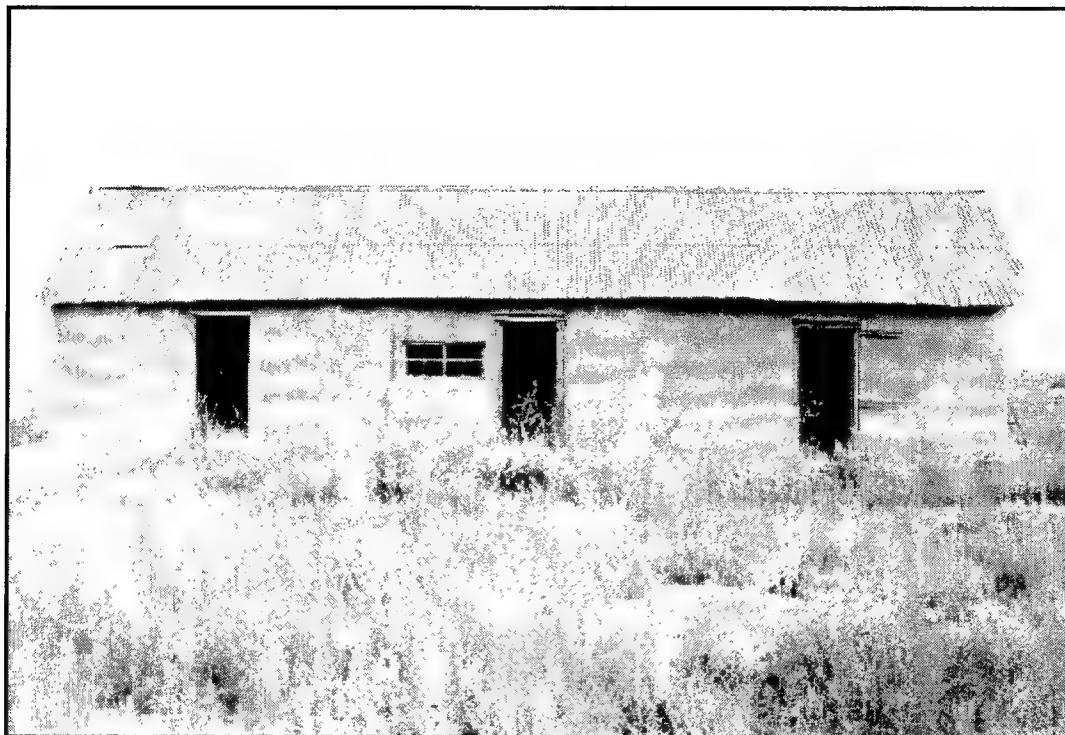
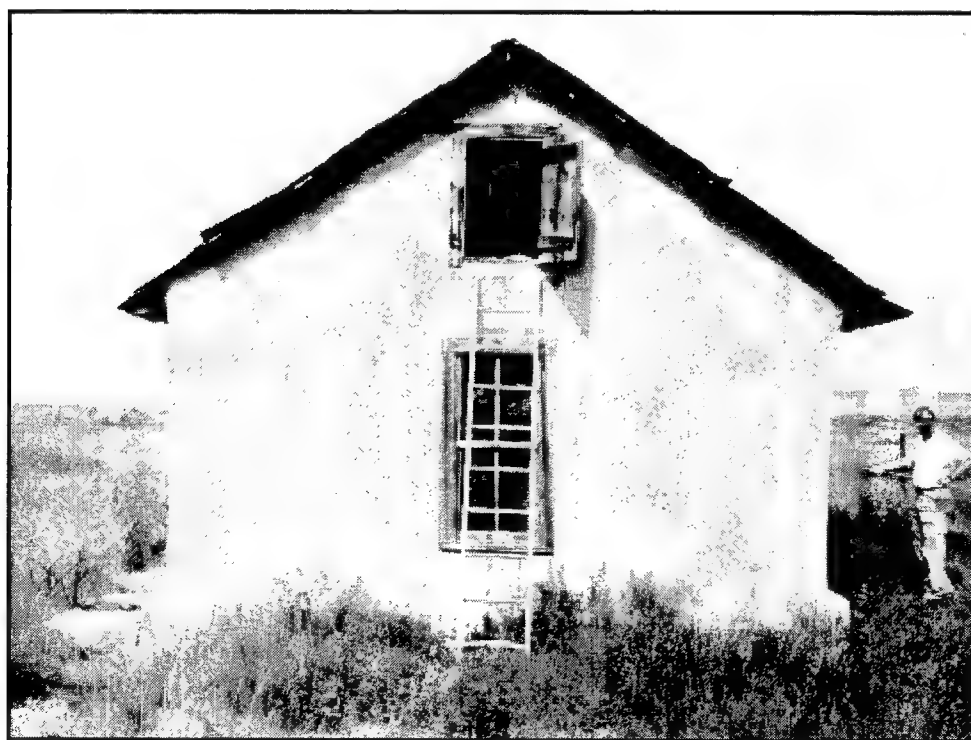
Figure 11. Structure A (Original Residence) south face (top) and east face (bottom) showing alto and gate at left.

The *alto* is a Hispanic design element which allows access to an uninsulated storage space created by the addition of the gable roof. The *alto* is accessible only by an exterior door constructed of two wood planks (Figure 11, bottom). This entrance has a full surround of 1"-x-4" boards, though the bottom member is now missing. The *alto* door is fastened with a slide bolt.

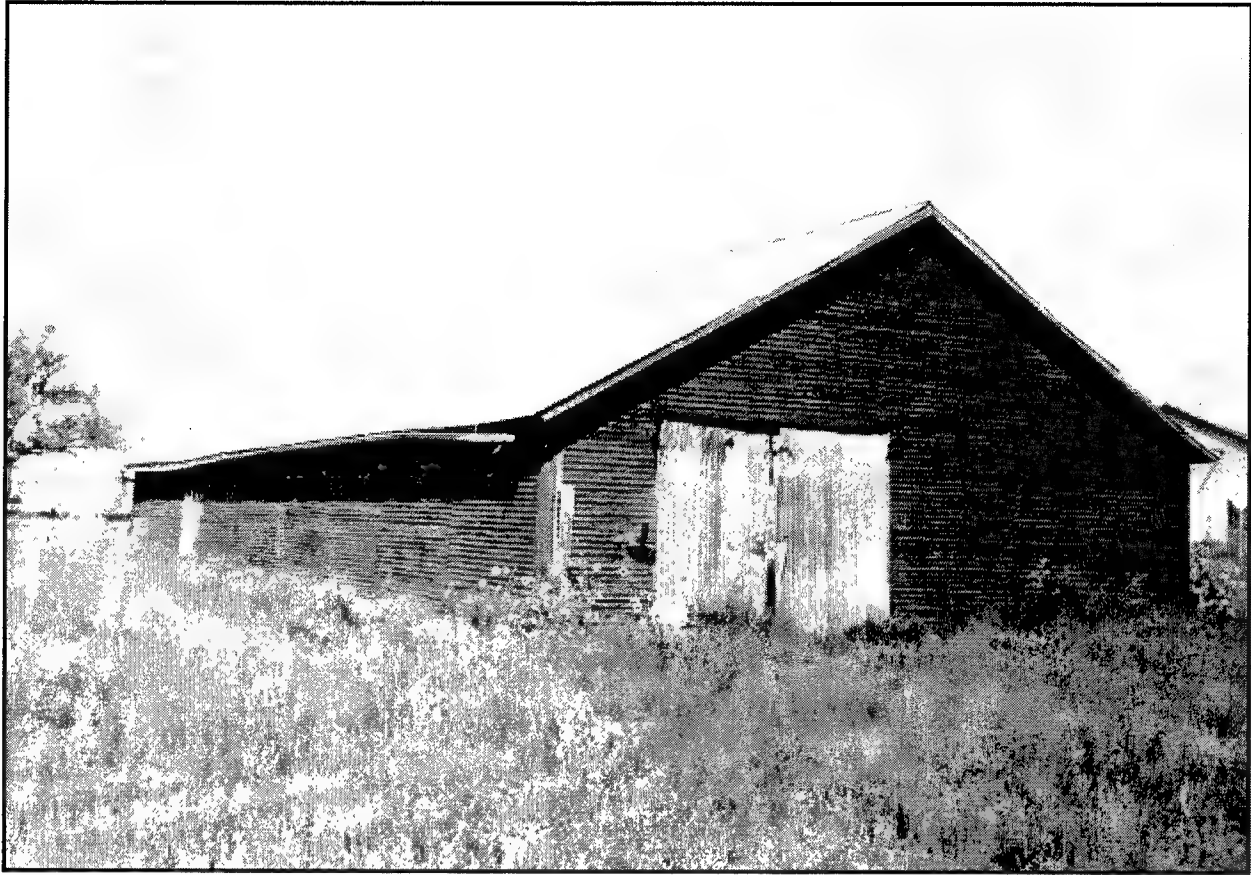
Figure 17. Structure D (Frame Barn), south and east faces.

Although documentation of the Frame Barn was not required for this project, some information was recorded on this structure. Structure D, the Frame Barn, is located on the southeast edge of the complex (Figure 3). Its wood frame construction is indicative of both regional and national architectural trends (Figure 17).
